Vivo X7 Repairability Assessment

Vivo X7 repairability assessment performed on January 9, 2017.

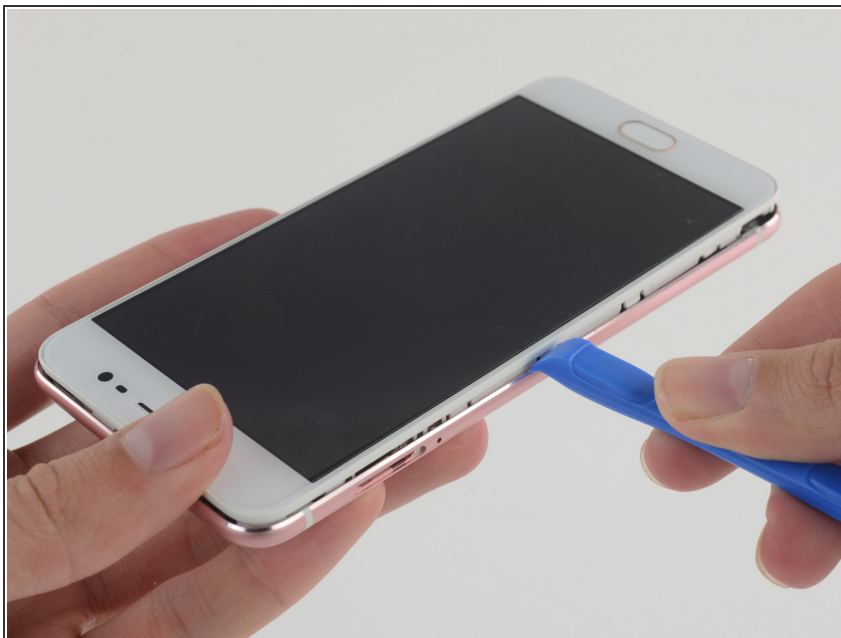
Step 2

- Extremely stiff clips keep the phone closed, even after removing the two T2 Torx screws.
- Use of metal tools may be required, which could damage the device during opening.

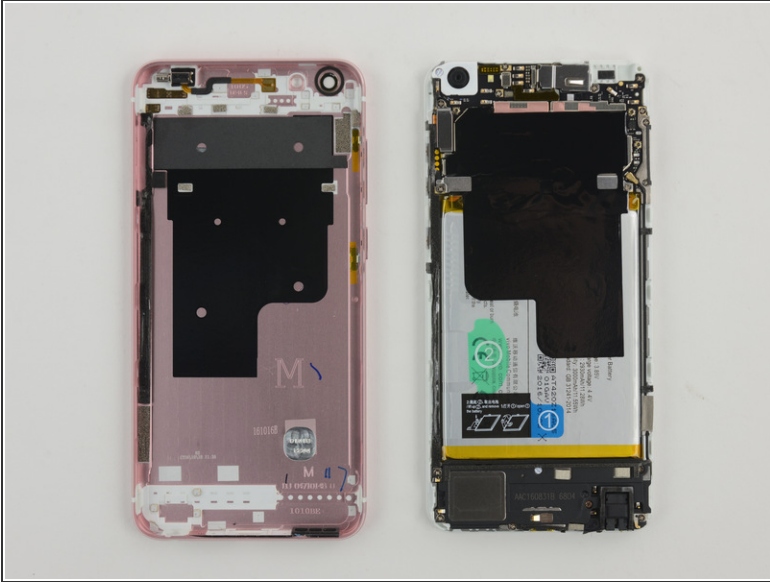
Step 3

- View of the inside.
- The only component in the rear case is a modular vibrator.

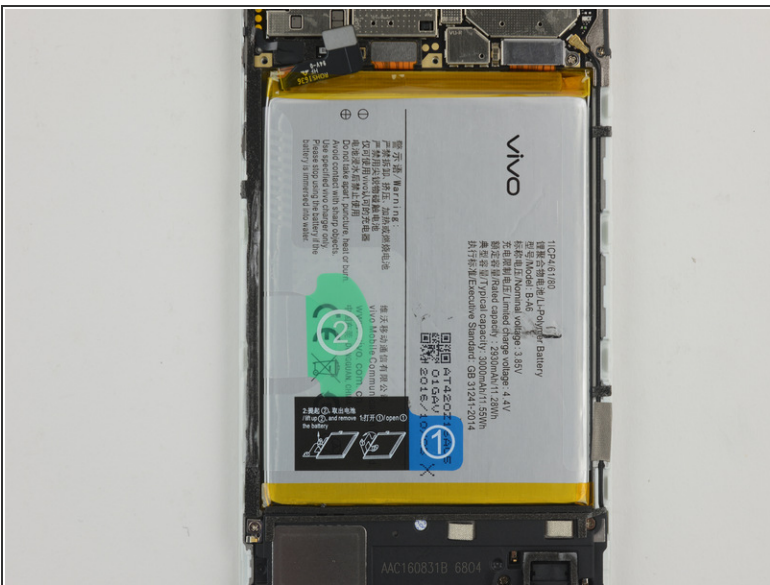
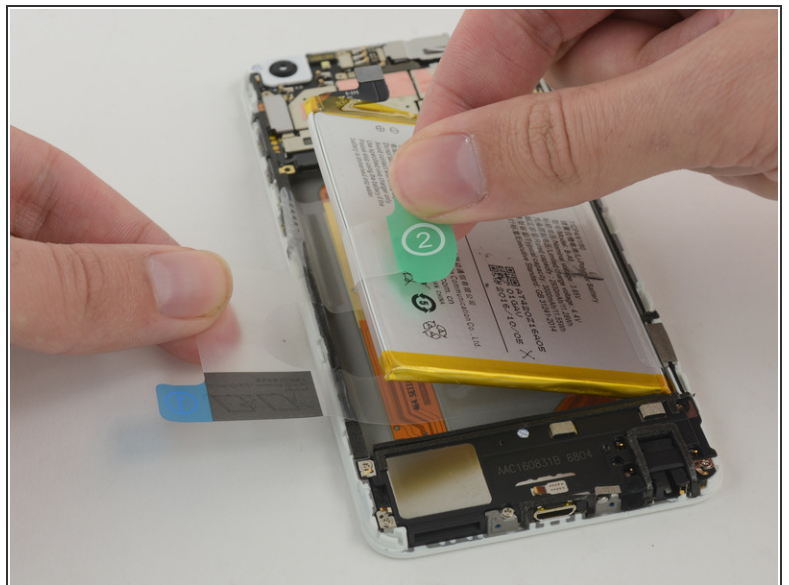
Step 4

- Battery tabs are very handily labeled!
- And very effective!

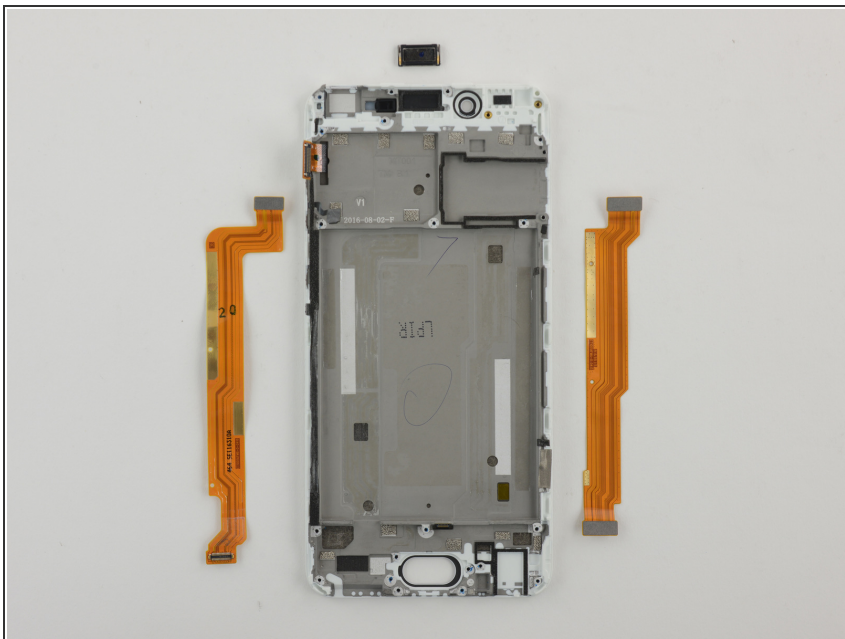
Step 9

- Final components off of the display are the interconnect cables and earpiece speaker.
- The midframe-mounted fused display makes for an expensive part. The fact that it is the last part to be removed makes screen replacements time-intensive.
